**SPE-195866-MS**

## **Overcoming Coring Challenges in a New Unconventional Play Offshore by Integration of Formation Evaluation Data**

Thomas Bradley, Baker Hughes, a GE Company; Per Henrik Fjeld, Jonathan Scott, and Steven Ogilvie, AkerBP

This paper was prepared for presentation at the SPE Annual Technical Conference and Exhibition held in Calgary, Alberta, Canada, 30 Sep - 2 October 2019.

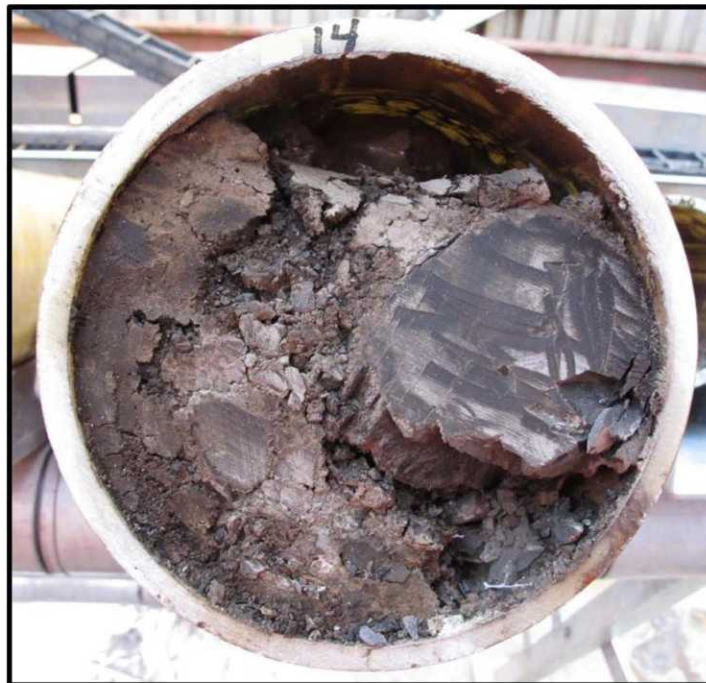
This is illustrated in Figure 2 which shows a section of the core from xx14 m, showing the typical condition of the recovered core when still in the core barrel.

Figure 2—Core photo of core 2 at xx14m. Considerable apparent damage can be observed in the core.

At the time of operations, poor recovery was attributed to coring practices employed and no further coring was attempted.

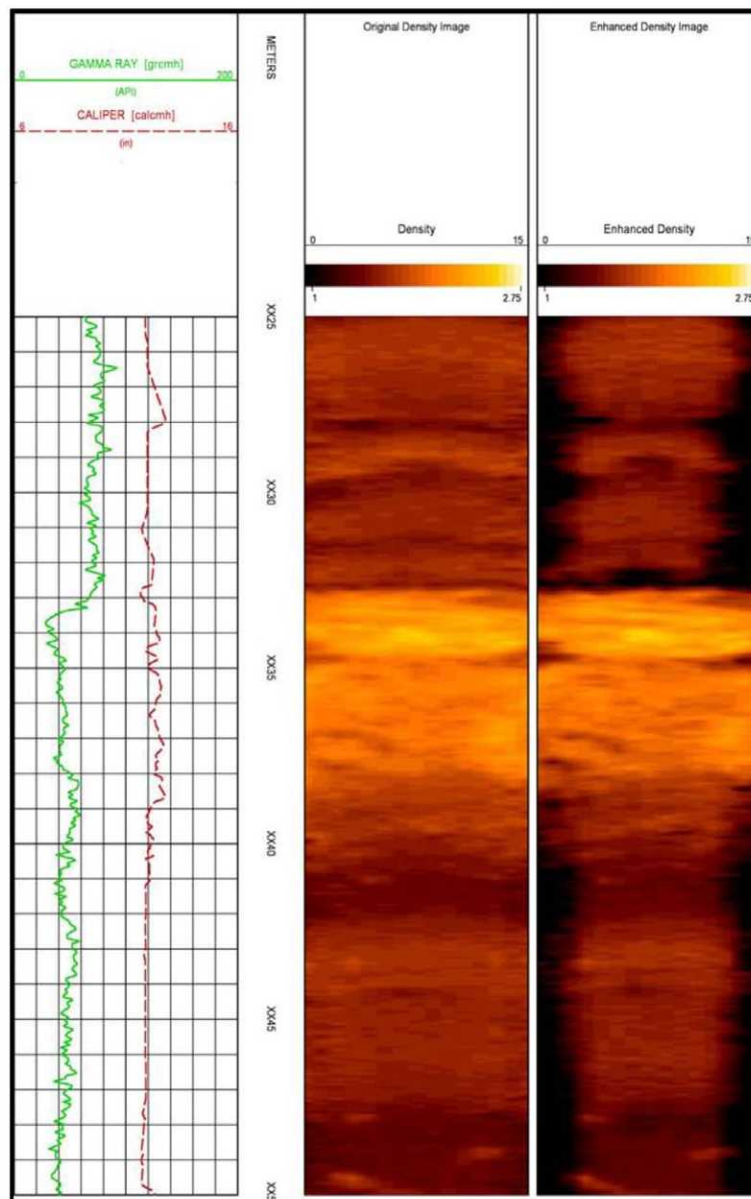
- Track 1 – gamma ray, calliper.
- Track 2 – depth

- Track 3 – bulk density image as logged
- Track 4 – resolution enhanced bulk density image

Over much of the image (Figure 4), the indications are that low angle to borehole planar bedding is present. However over the interval from xx33 to xx38m this trend changes. Because of the relatively low resolution of LWD bulk density images compared to other imaging technologies (even after resolution enhancement) the individual beds cannot be seen, but the general image character indicates disturbance in the bedding compared to above and below. This corresponds with the change in the azimuthal anisotropy direction from the overall trend observed in the azimuthal anisotropy analysis; therefore a further line of evidence to the presence of a localised structure.

Figure 4—logged and enhanced density image. Refer to text for detailed description of figure

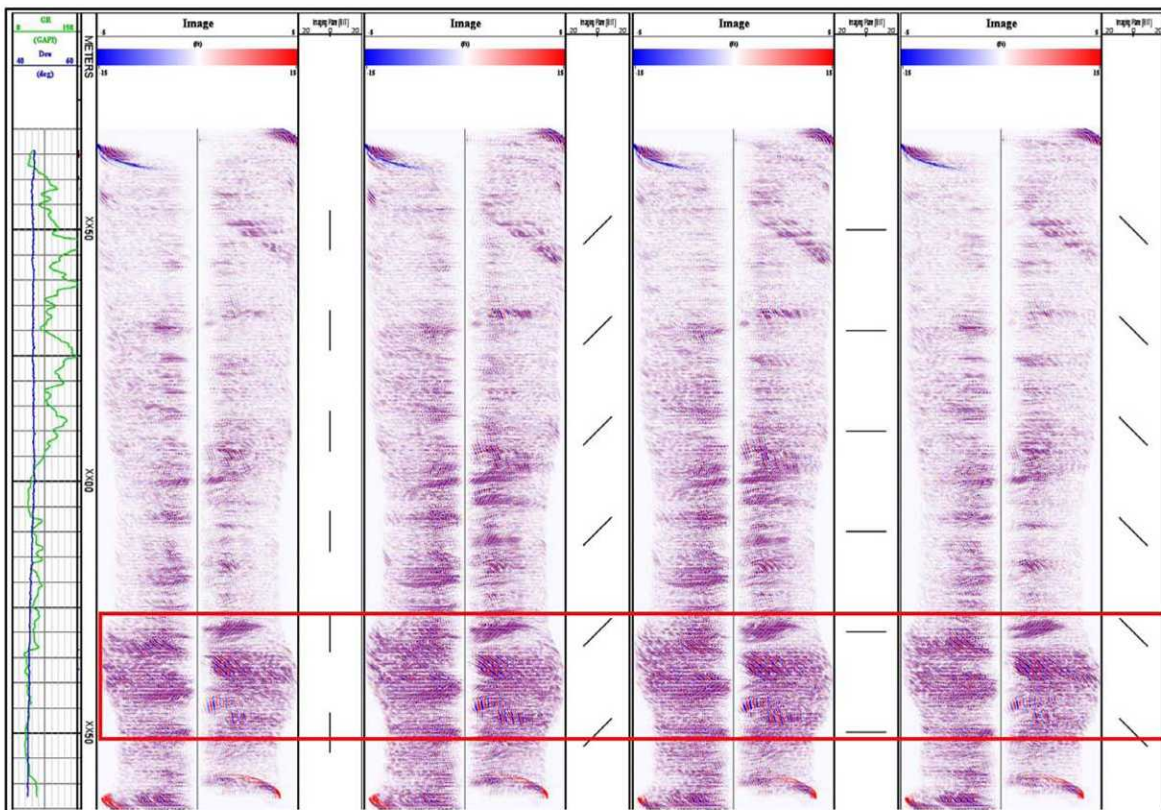
Figure 6—radial shear reflection images at zero, 45, 90 and 135 degrees. Refer to text for detailed description of figure

- Track 1 – gamma Ray, borehole deviation.
- Track 2 – depth.
- Tracks 3,5,7,9 – reflection images plotted at imaging plane orientations of zero, 45, 90 and 135 degrees to north, with the borehole in the centre of the image, and the track edges representing a distance of 5 metres from the borehole.
- Tracks 4,6,8,10 – sticks indicating orientation of imaging planes.

The images display reflections from planar features in the formation. Of particular interest is the strong reflection present intersecting the borehole at approximately xx35m (highlighted by the red box). As this can be observed to a certain degree in all planar orientations, this suggests that a very high acoustic impedance contrast is present between the reflecting feature and surrounding formation.

High acoustic impedance contrasts are commonly associated with structural features such as fluid filled fractures and faults. The amplitude of the reflection here suggests that the feature has a large aperture, or has a significant damage zone either side of the feature, hence strongly suggesting that the reflecting feature is a fault.

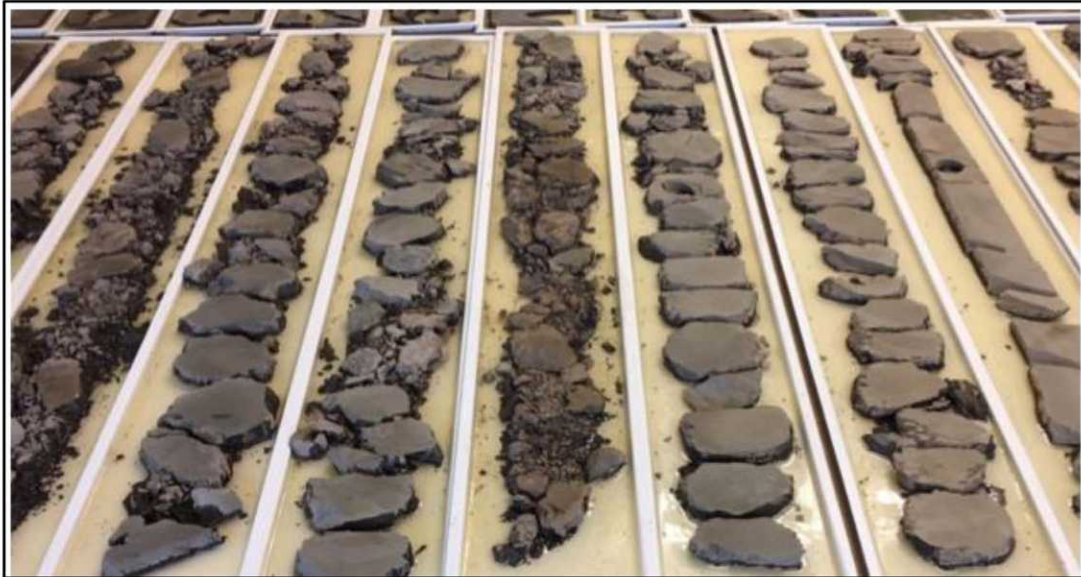
The well penetrates a mapped fault at approximately the location of a circa 19m long rubble zone (from circa xx08 to xx27 m) observed in the core (as shown in Figure 8).

Figure 8—Photo of core from 19m long rubble zone from xx06.5 to xx25.5m (core 2)

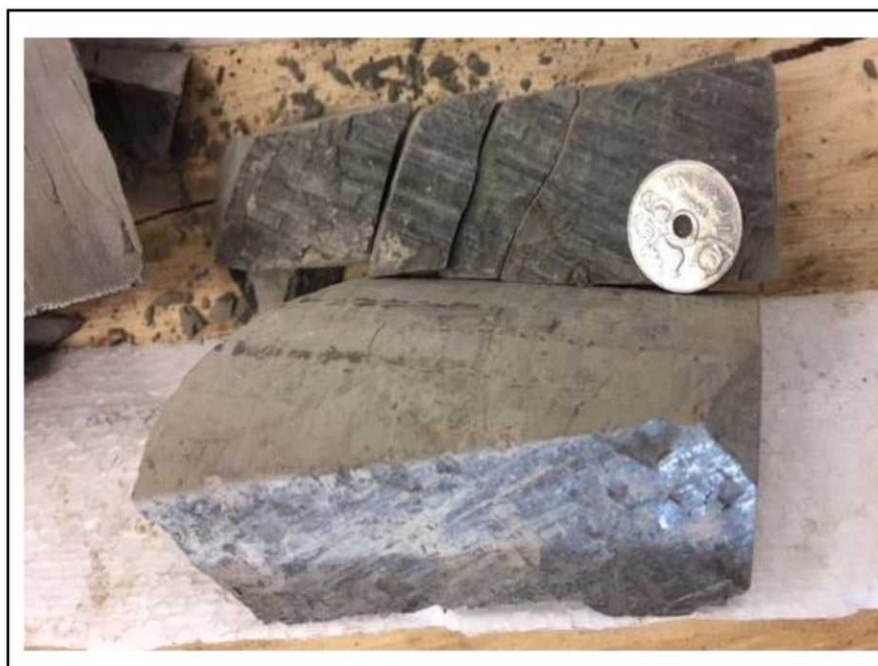
It is likely that the rubble zone extends beyond the cored section based upon the logging evidence already presented. Potentially to at least xx40 m MD. Deeper in the cored section (at xx82 m MD), an 8m zone of discrete fractures with well-developed slip planes and slickenlines are present (as shown in Figure 10).

Figure 10—slickenlined shear fracture deeper in the cored section

This is considered to be a damage zone related to the fault identified in the seismic data.
